Evaluation of NYC's Coastal Vulnerability and Potential Adaptation Strategies in the Wake of Hurricane Sandy

Authors: Miller, Stephanie; Foti, Romano; Yu, Ziwen; Daley, Jad; Elwell, Hollyl; Matsil, Marc; Montalto, Franco

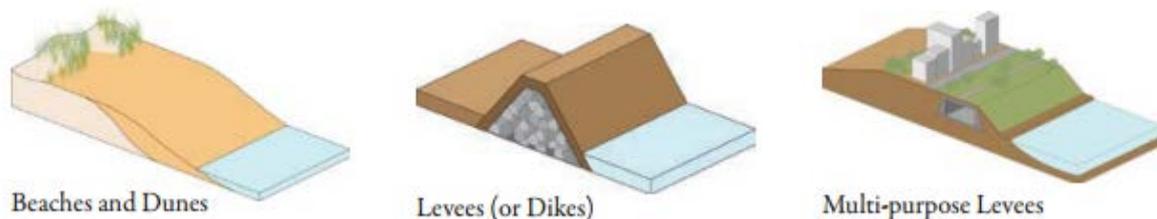
Figure 1: Examples of "green," "hard," and "hybrid" coastal engineering features. Source: NYC DCP 2013

construction of storm surge barriers, levees, sea walls, groins, bulkheads, tide gates, and armored stone barriers (NYC 2013, NYC DCP 2013) (Figure 1). Although costly to build and maintain, previous research has shown that they can be effective at reducing wave damage, keeping out storm surges and protecting coastlines from imminent sea level rise (Coch 2012, NYC 2013, NYC DCP 2013). The “green” strategies included in NYC’s coastal protection plan include beach nourishment, dune construction and stabilization, and the creation and maintenance of living shorelines, including wetlands (NYC 2013, NYC DCP 2013) (Figure 1). Jointly referred to here as green infrastructure (GI), these strategies utilize soil and vegetation to mimic natural functions and processes, facilitating infiltration, detention, or other benign redirections of water. These strategies are believed to be able to mitigate coastal risks while restoring, enhancing, or creating new forms of urban habitat and providing other valuable ecosystem services (Montalto and Steenhuis 2002, Wilks 2011, Temmerman et al. 2014, Spalding et al. 2014). GI systems are also believed to be useful in managing stormwater, creating recreational opportunities, and mitigating the urban heat island effect. They are considered by some to be more cost-effective than equivalent hard engineering approaches to the same problems (Gedan et al. 2011, Spalding et al. 2014, Barbier 2015). “Hybrid” solutions combine the physical barriers of “hard” engineering with the aesthetic and

habitat features from “green” solutions (Figure 1).

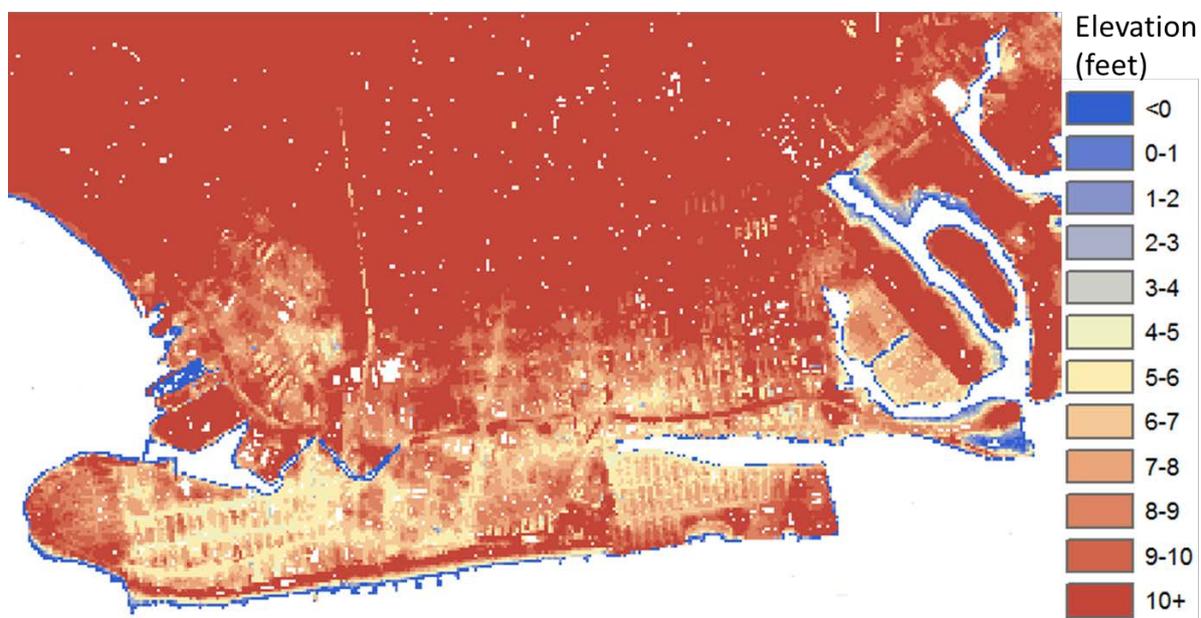
Figure 3: Elevation map of the Coney Island study area.

One relationship which appears counterintuitive is the relationship between elevation and damage. One would initially expect that if houses closest to the beach were more damaged, elevation would also be directly proportional to damage. In fact, Model 2 suggests that a one unit increase in elevation actually increases the odds of being damaged by 18.69% (Table 5). The topography of Coney Island provides one possible explanation (Figure 3). Elevation is actually higher nearest the beach and close to the shore. The analysis presented here cannot explain how these three variables (elevation, distance to the coast, and bare earth) interacted with one another, but the results clearly indicate that buildings subject to the triple threat of surge, wave damage, and severe winds were more likely to be damaged than those further inland. Future studies are needed to confirm whether these buildings actually protected houses further inland from the worst of the storm.

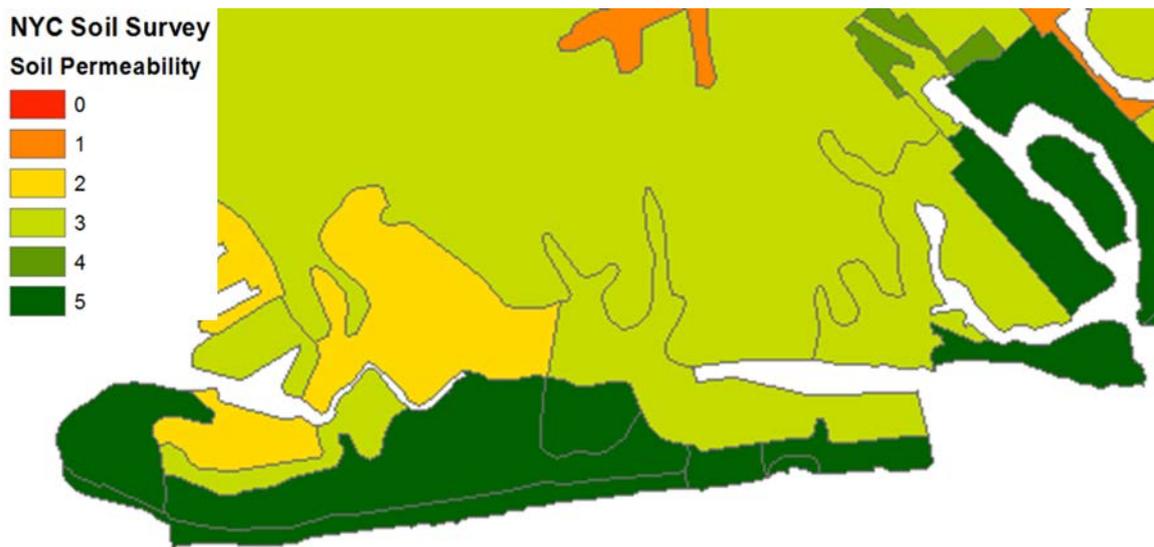
Figure 4: Map of soil permeability for the Coney Island study area.

The last very important predictor of damages on Coney Island is soil permeability. Soil permeability is measured on a scale from 0-5, with 0 representing very slow permeability and 5 very fast. The regression suggests that houses with higher permeability were more likely to be damaged than those with lower permeability. A one unit increase in soil permeability increased a property's odds of being damaged by more than 80% (Table 5). The soil permeability map for Coney Island reveals that the most permeable soils are found right along the coast, near beaches and parkland, with a large concentrations of high permeability sand (Figure 4).

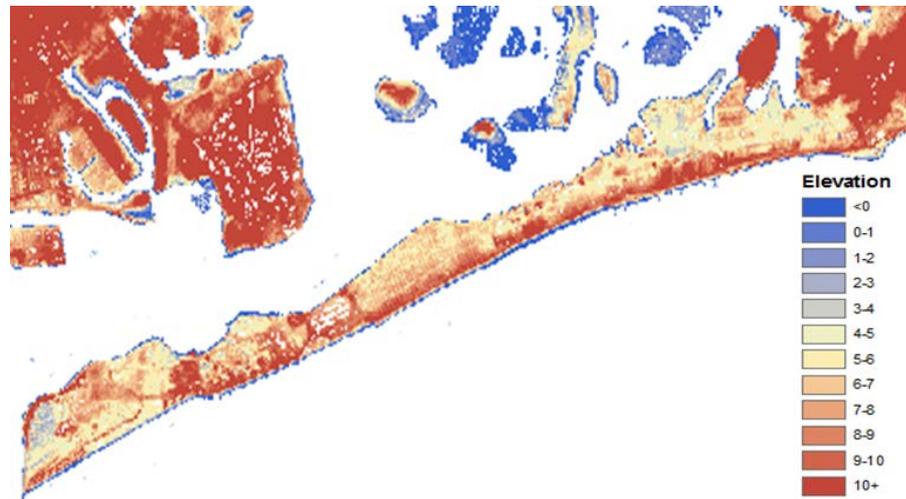
Figure 5: Elevation map of Rockaway Peninsula.

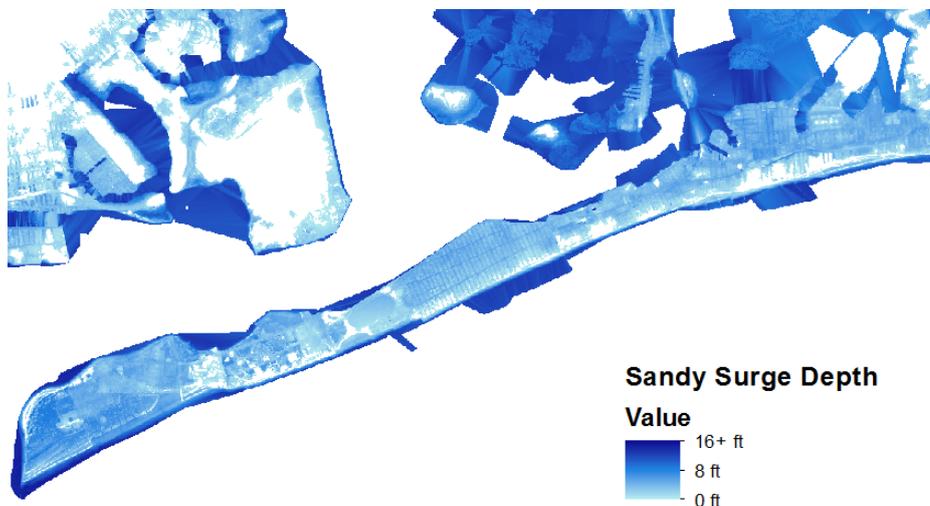
Figure 6: Map of surge depth on the Rockaway Peninsula during Hurricane Sandy.

Where dunes protected the seaward coast, some neighborhoods were not inundated at all (Figure 6). The worst flooding on the Rockaways came from Jamaica Bay. Storm forcing on the deep, dredged channels of the Bay pushed large quantities of water over the back of the barrier island. The wide, bayside floodplain then exposed a number of houses, many far from either coast, to significant flooding and associated damages.

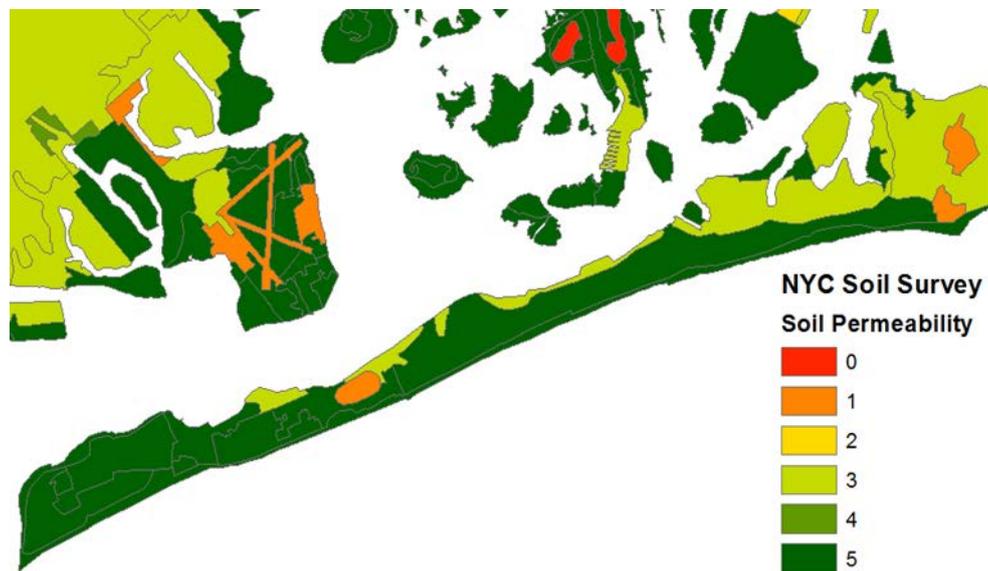
Figure 7: Map of soil permeability on Rockaway Peninsula.

Another factor that was an important predictor of damages was soil permeability. The regression suggests that houses with lower soil permeability were more likely to be damaged than those with higher permeability. A one unit decrease in soil permeability increased a property's odds of being damaged by almost 70% (Table 6). This is exactly the opposite trend to what occurred on Coney Island. A possible explanation is that in the Rockaways, the most permeable soils are typically found on the ocean-side, (Figure 7). On East Rockaway and

near Jamaica bay, soil permeability is decreased due to the presence of clay, likely due to the filling of historic wetlands in these regions. It is possible that the poor permeability of the island's bayside contributed to the damage in that region since these soils would have constrained the rate that ponded water could have infiltrated post-Sandy. It is, however, also possible that this finding is merely coincidental. In other words, the flooding happened to be more severe, and to create more damage, in the portions of the island that just happened to have less permeable soil. A detailed investigation into the nature of the types of damage found on the bayside of the island might be able to help untangle whether damage was immediate or due to prolonged flooding.

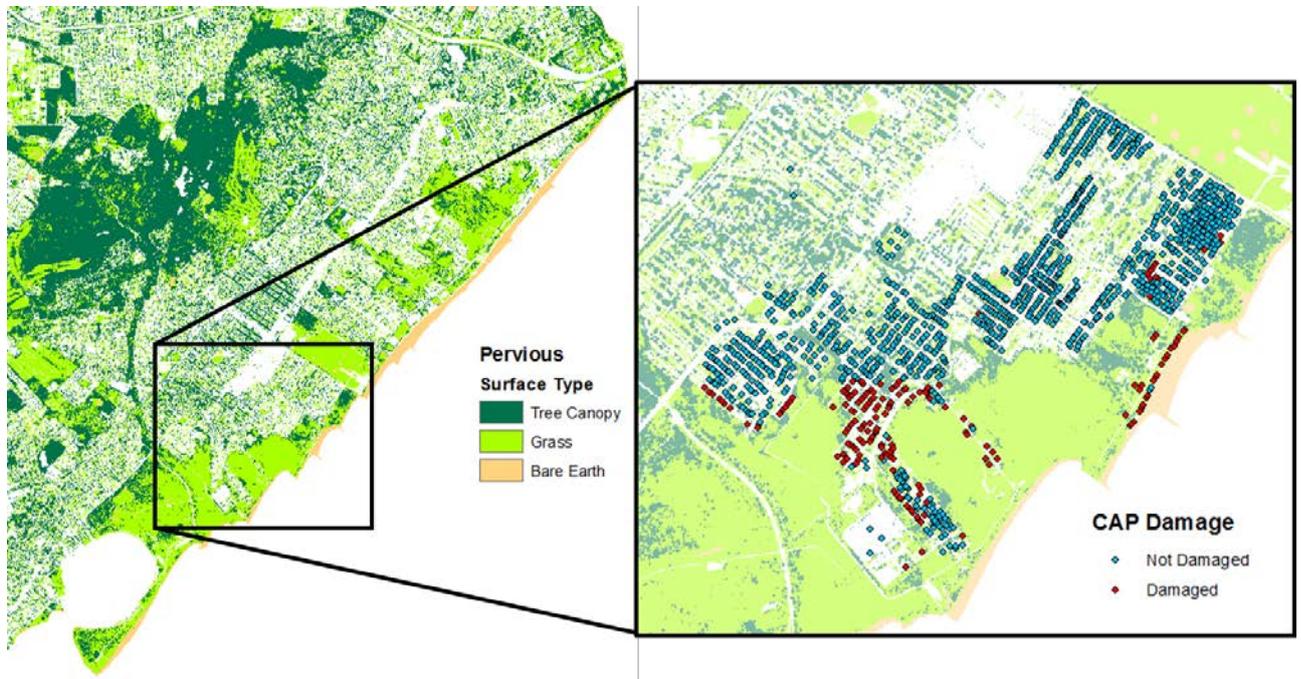
Figure 8: Map of tree canopy, grass, and bare earth coverage on the South Shore, Staten Island. In-set shows CAP damage classifications (damaged or not damaged) for houses in the South Shore study area.
